Re: Magna Metals Site - #3-60-003
510-534 Furnace Dock Road
Cortlandt Manor, New York

RE: Sub-slab Depressurization System (SSDS) – 2015 Annual Inspection

**System Inspection Field Form
Soil Vapor Mitigation Systems**

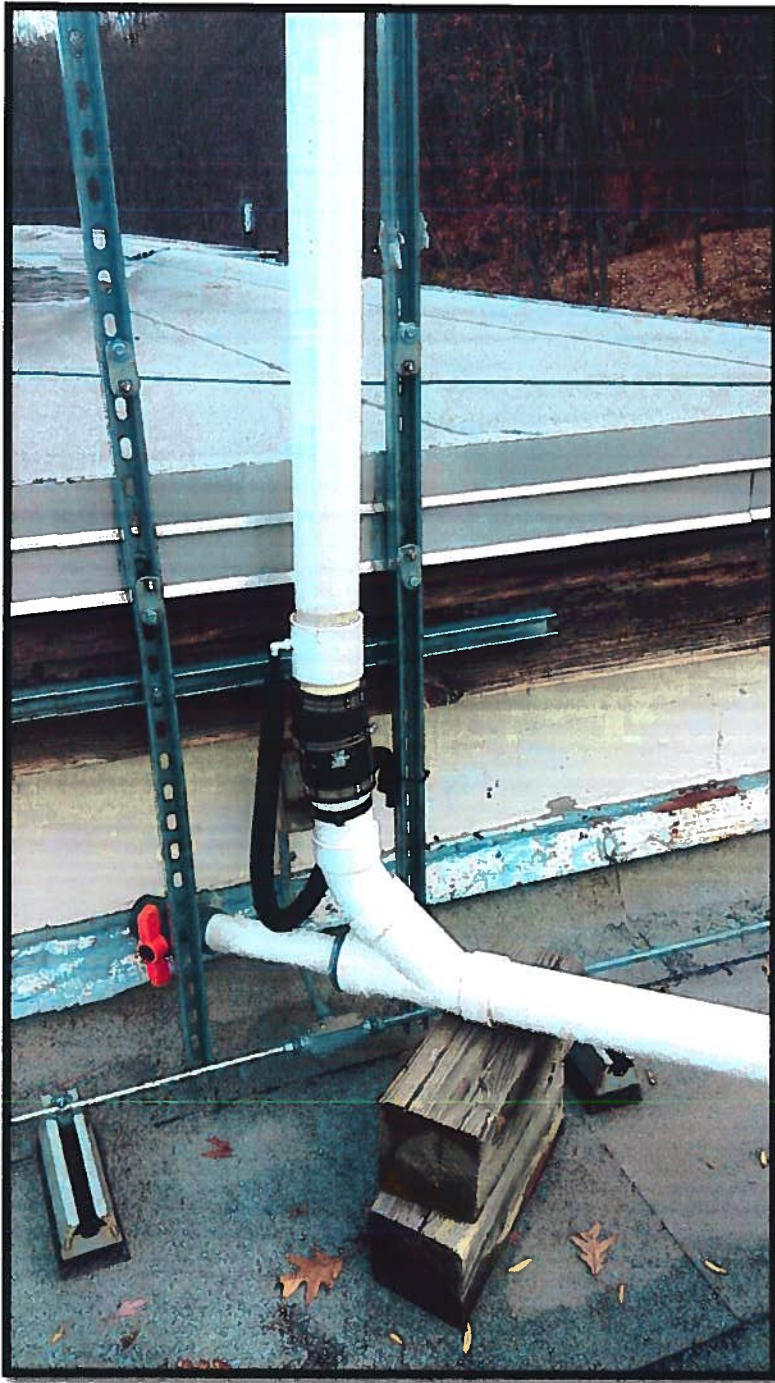
On November 4th, 2014 a team of two qualified technicians mobilized to the site to inspect the cause of the alarm. The fan was found to have tripped the Ground Fault Circuit Interrupter (GFCI) outlet. Once reset, the fan worked for a short period of time until an internal protective device shut the fan down. The technician tested the circuit and the fan and determined that the fan was over-heating due to an excessive amperage draw. Aztech personnel removed the fan from the mounting structure on the roof and brought it back for evaluation. The plumbing was left in place to act as a passive ventilation system.

Photo depicts location of System 3 upon arrival acting as passive ventilation system
prior to re-install of repaired fan.

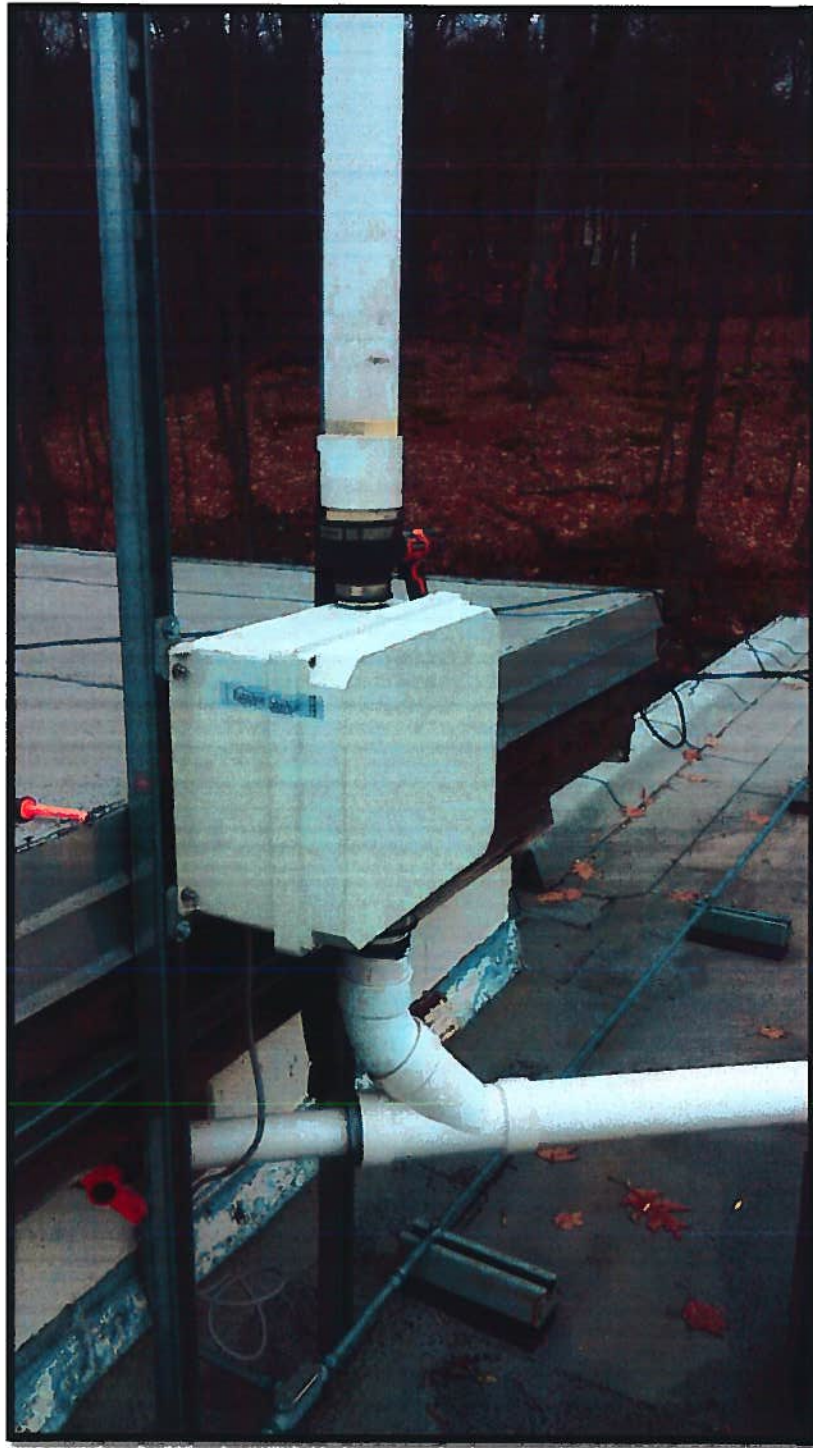
Photo depicts Fan #3 after being re-installed.

Aztech contacted the fan manufacturer and coordinated the repairs under the extended warranty purchased for this fan. The repairs were made and the fan was returned to Aztech on December 4th, 2014.

On December 5th, 2014 Aztech personnel mobilized to the site to re-install the fan and conduct the annual system inspection.

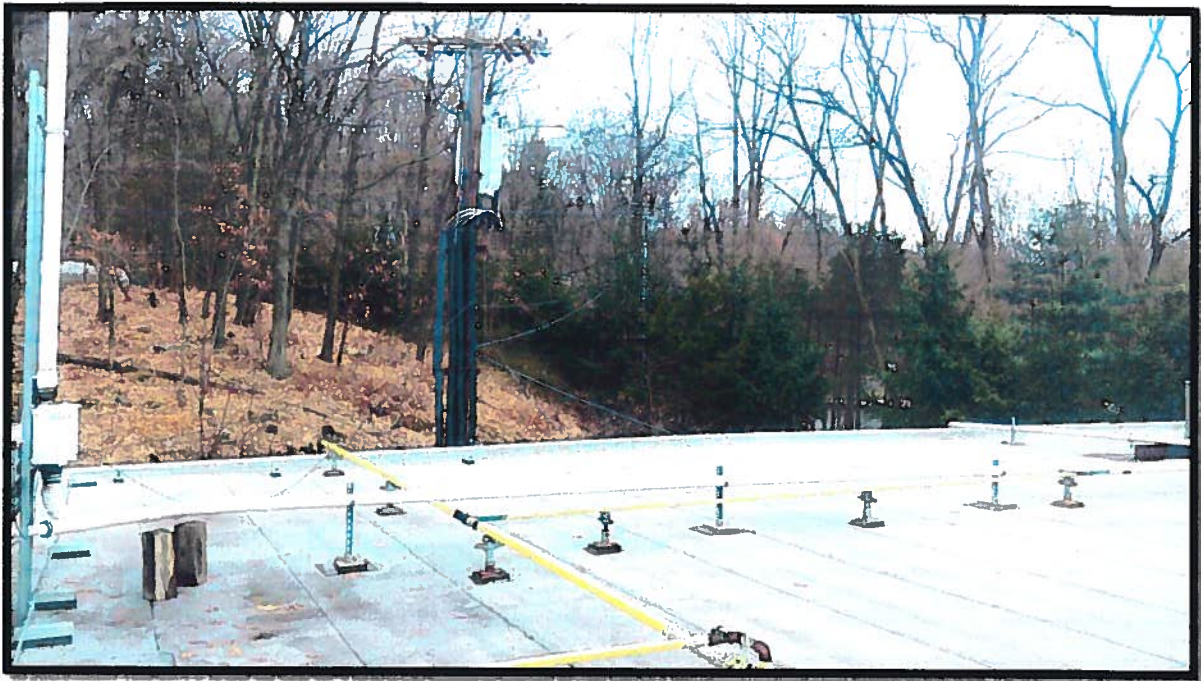
Photo depicts lateral piping for system 3 after support brackets were adjusted to create a better pitch for condensation flow.

During the inspection, it was noted that the lateral piping located on the roof and held by supports may have shifted due to weather conditions. The supports were re-adjusted to create a more consistent pitch away from the inlet of the fan to allow for accumulated condensation to flow back down into the extraction point beneath the building slab as designed.

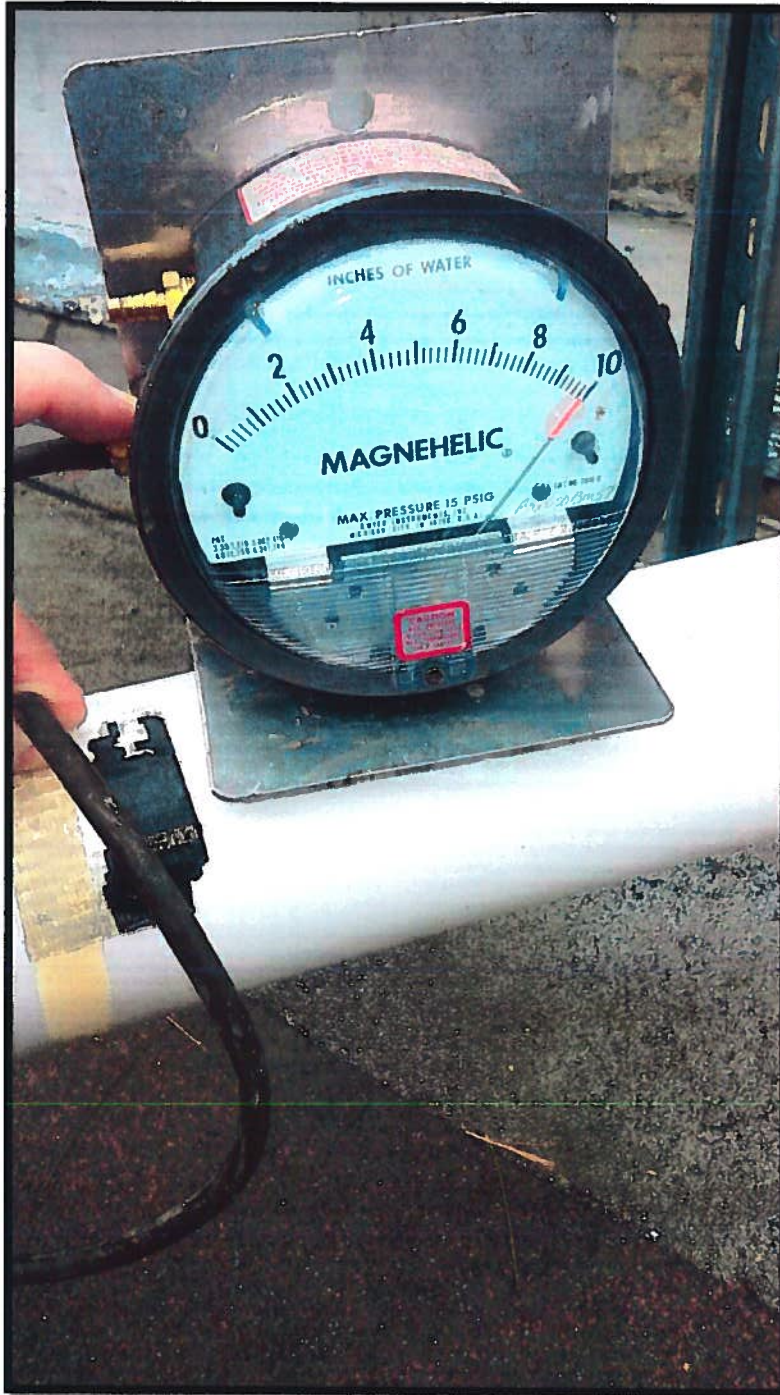
Photo depicts vacuum measurement of system #3.
